TEST REPORT

Test Model: ZM-H16

| Report Type: Test Report | Product Name: ALL IN ONE PC |
| Report Number: | 2402Y102291E-SF |

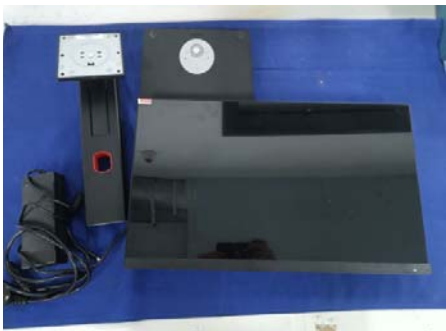
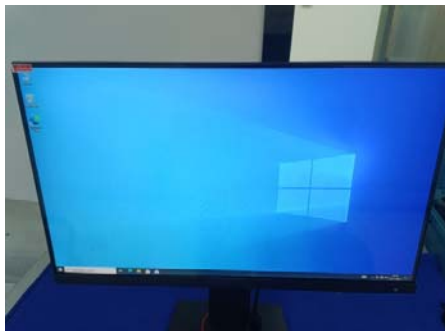
4. Sample Photos before the Test

| Sample No. | Initial Test |
|---|--|
| 2402Y102291E-SF-S01 | The appearance of the sample is normal, and the startup is normal. |
